Mobile Intel[®] Celeron[™] Processor at 466 MHz, 433 MHz, 400 MHz, 366 MHz, 333 MHz, 300 MHz, and 266 MHz Specification Update

Release Date: May 2001

Order Number: 244444-025

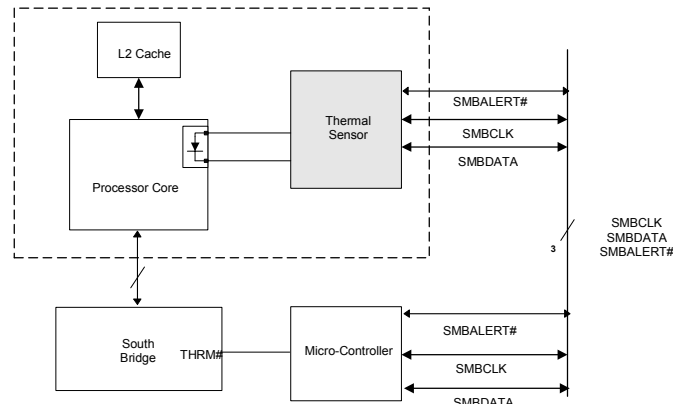
Figure 1. An Example of Microcontroller Driven Thermal Management

H29. Thermal Sensor May Assert SMBALERT# Incorrectly

Problem: The Intel Celeron Processor Mobile Module has a thermal sensor that monitors the processor core's temperature. Please note that desktop systems could have a similar thermal device. The thermal sensor asserts SMBALERT# if the processor temperature exceeds the temperature limits set in the Alarm Threshold Registers (T_{HIGH} , T_{LOW}). It also sets the corresponding Status Register bits to identify the cause of the interrupt. Figure 1 gives one example of the how the SMBALERT# signal could be used in a system.

Implication: There is no system impact from this erratum if temperature polling is used for processor thermal management. If the SMBALERT# interrupt is employed to manage processor thermal sensing, then servicing the false interrupt may result in premature system action depending on the software and hardware implementations used. The rate of the false interrupts is less than the auto-convert rate of the thermal sensor.

Workaround: Three different (mutually exclusive) workarounds are possible:

1. Before servicing an interrupt from the thermal sensor, read and compare the processor thermal reading with the threshold limits (T_{HIGH} or T_{LOW}). Figures 2 and 3 provide basic flowcharts for the implementation of this workaround in an interrupt driven system.
2. If the firmware implemented polls the Status Register only, then before taking any action, re-read the temperature register and do a comparison with the alarm threshold limits (T_{HIGH} or T_{LOW}) to determine if the value is actually still within the temperature window.
3. Use a temperature polling scheme to monitor the processor temperature.

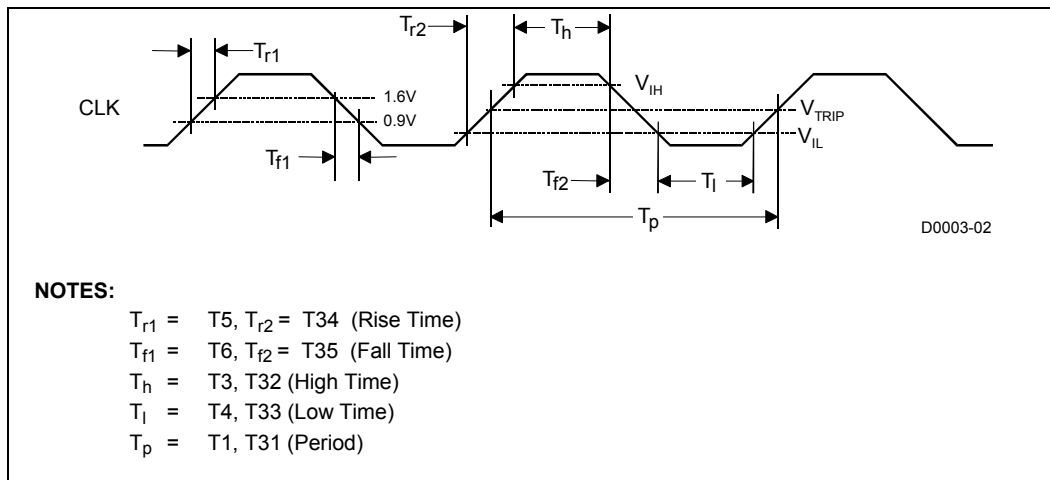
Figure 3.3 Generic Clock Waveform

H11. Generic Clock Waveform Figure

Figure 3.3 in the Intel® Mobile Celeron™ Processor in μ PGA1 and BGA1 Packages at 366 MHz, 333 MHz, 300 MHz, and 266 MHz datasheet (Order Number 245112-003) has been updated. The following figure is to replace the one in the above document.
